SOUTH WEST IRRIGATION MANAGEMENT COOPERATIVE

Report to the Department of Health for the Period 01 October 2022 to 31 December 2022

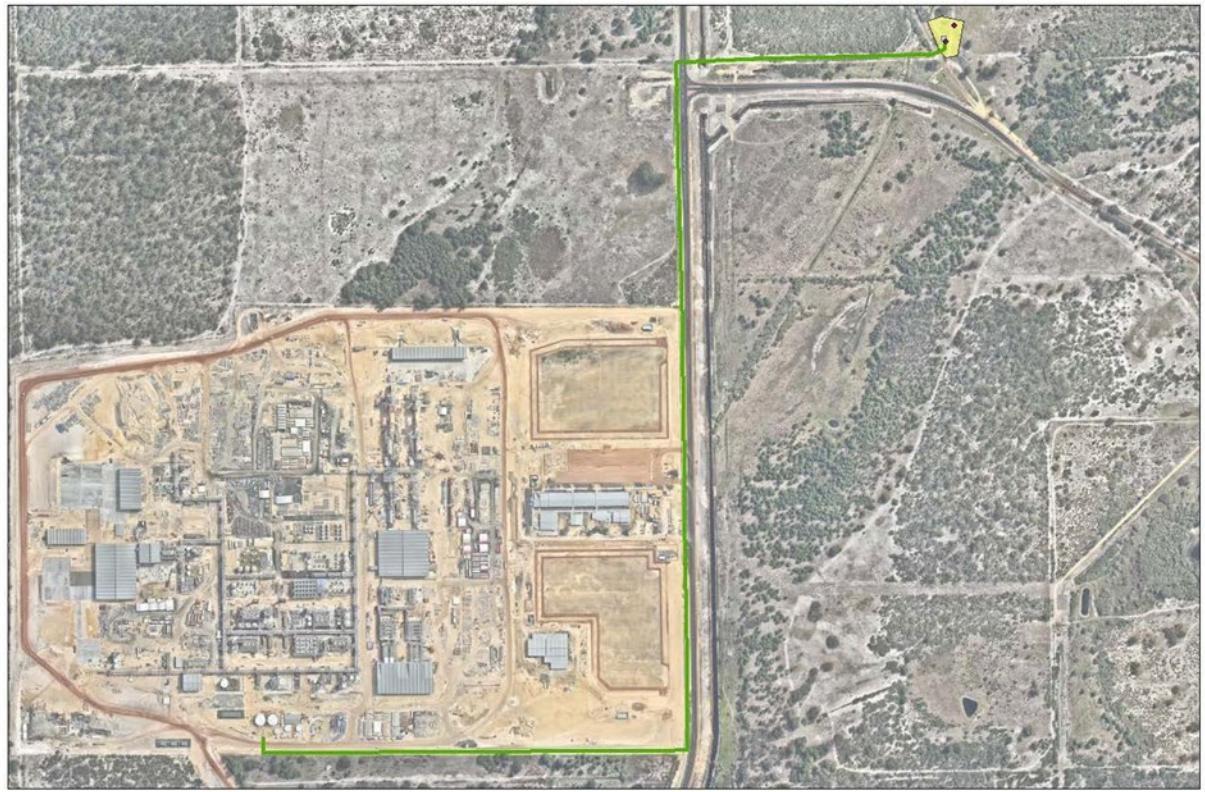
Harvey Water has installed a bore into the Leederville aquifer to supply water for treatment to the Albemarle Lithium processing plant in Kemerton. The bore is located on lot 253, 2km away from the water treatment plant (WTP) which is located within the Albemarle lithium processing plant as indicated in Figure 1. Water from the bore is treated through a WTP designed to bring in accordance with the Department of Water and Environmental Regulations (DWER), the Department of Health (DoH) and the Australian Drinking Water Guidelines (ADWG).

Raw water is drawn from the bore using a downhole pump activated through a level sensor. This pump provides water to the WTP where it is treated through a system of filters and chemical dosing. Water is initially passed through a 100% glass multimedia filter to remove large particulates from the source water. After the multimedia filtration, water is chlorinated using sodium hypochlorite. Chlorinated water is then passed through a DMI media filter which utilises catalytic filtration media for the removal of iron and manganese.
